SWAN LAKE DAM

SULLIVAN COUNTY, NEW YORK

INVENTORY NO. N.Y. 333

PHASE I INSPECTION REPORT NATIONAL DAM SAFETY PROGRAM

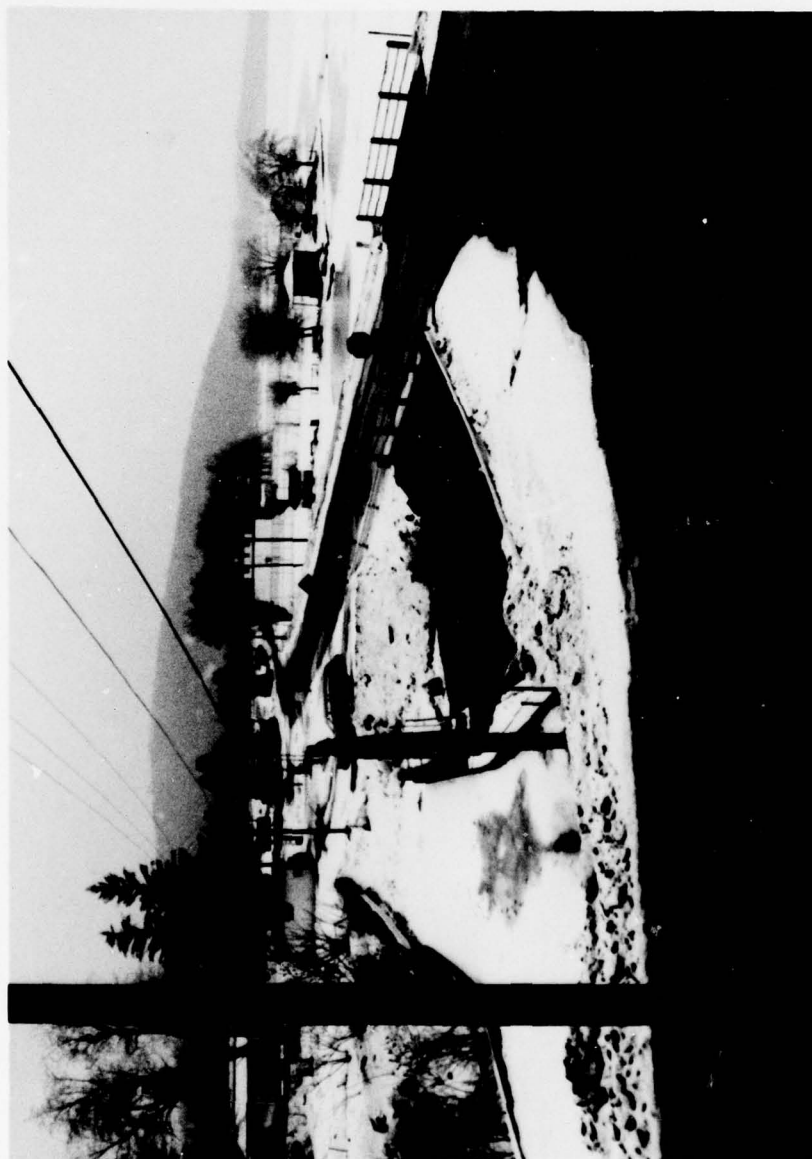
Photo #1

OVERVIEW OF SWAN LAKE DAM

The abandoned spillway bridge which covers the entire spillway is reducing the spillway flow (see photographs #1, 2 & 14). In addition, the bridge slab is cracked and deteriorated. The slab exhibits signs of calcification and appears to have contracted relative to the abutment walls which form the walls of the spillway. The limited spillway capacity and the deteriorated condition of this bridge may necessitate its removal.

- a. The abandoned spillway bridge and the utility lines suspended beneath the bridge must be removed to increase spillway capacity.
- b. The spillway stoplogs should be replaced with flashboards which collapse at a specific reservoir level.

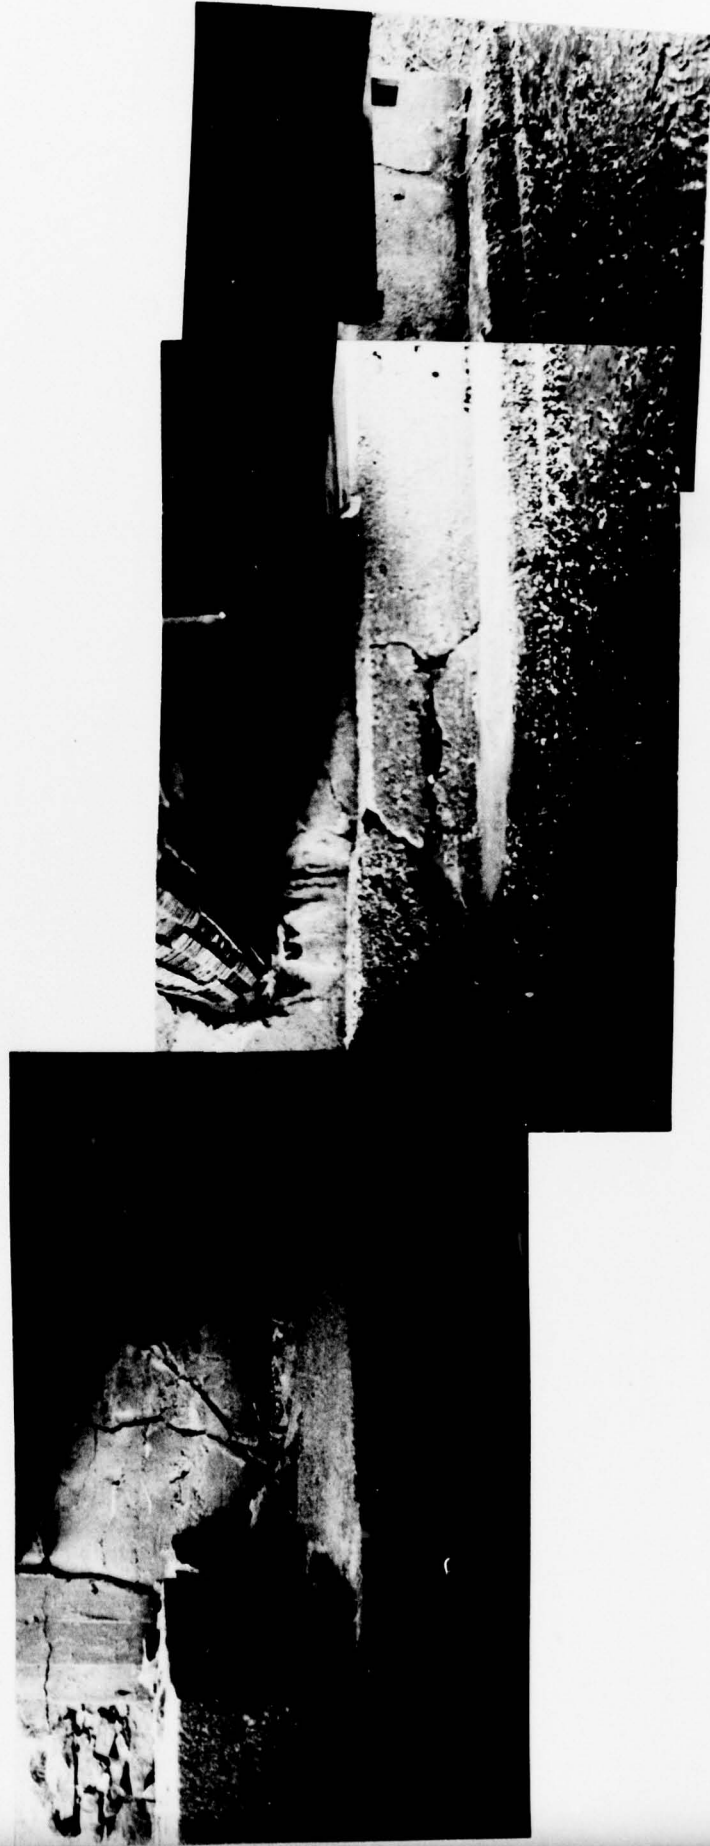
Photos #3A, B & C

EAST ABUTMENT WALL
NOTE CRACKING & DETERIORATION

- b. Structural Cracking Numerous structural cracks observed on
both east & west abutment walls of spillway + southeast wingwall
Bridge deck: observed extensive cracking & calcification

- c. Erosion at the base of the metal bin wall near the southeast corner of the spillway must be repaired.
- d. Cracking and deterioration of the spillway slab and walls must be repaired.
- e. Periodically monitor the bulge on the downstream masonry face in the vicinity of the penstock to determine if further movement is occurring. Periodically monitor the seepage from the penstock and the reservoir drain to ascertain changes in flow.
- f. Provide a reservoir drain to lower the lake level for future maintenance and repair work.
- g. Initiate a program of periodic inspection and maintenance of the dam and appurtenances. Document this information for future reference. Also, develop an operations manual.

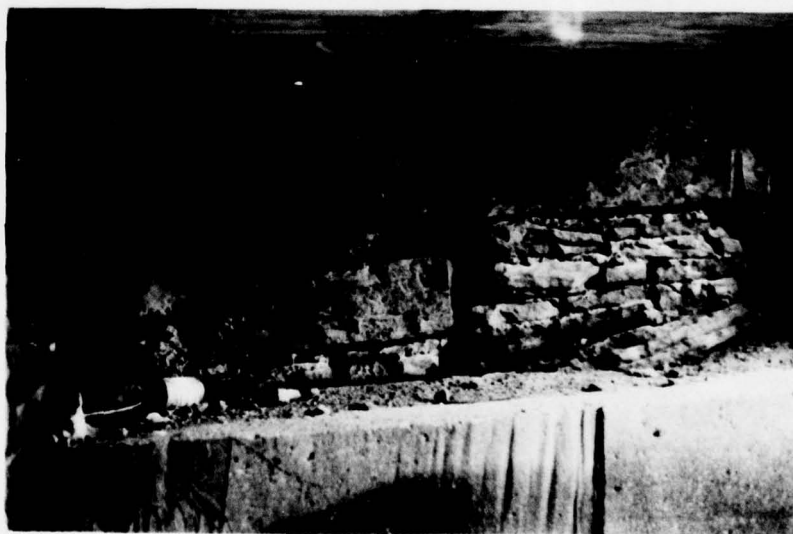
Photo #6

WEST ABUTMENT WALL
NOTE DETERIORATED MASONRY

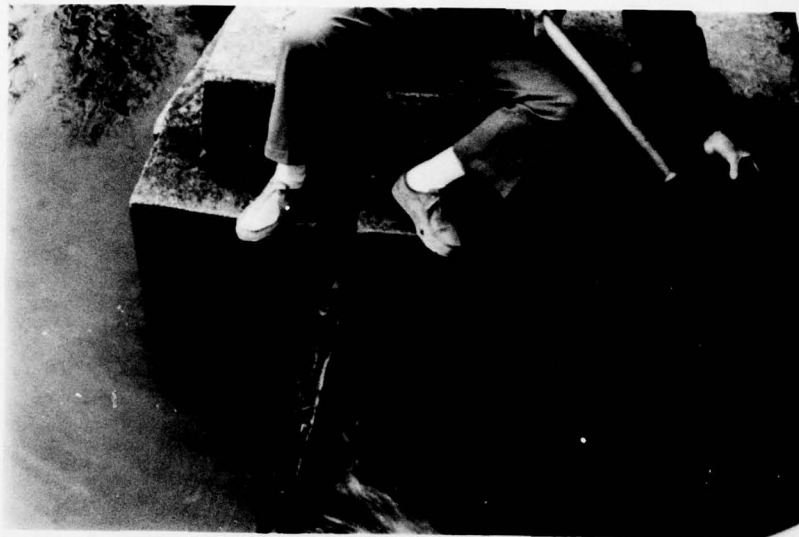
Photo #7

STOPLOGS

2. The spillway stop logs should be replaced with collapsable flashboards which fail at a specific reservoir level. This should be accomplished within 1 year of notification.

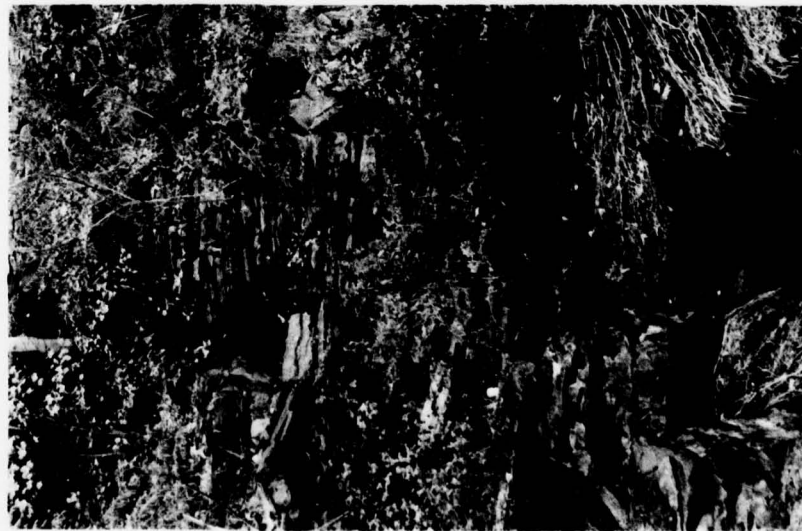
Photo #9

PENSTOCK AS VIEWED FROM BASE OF DAM

- d. Junctions with Abutments or Embankments _____
no apparent problems
- e. Drains - Foundation, Joint, Face _____
None
- f. Water passages, conduits, sluices 42" penstock on west side of spillway
is inoperative & badly deteriorated. Seepage ≈ 5 gpm flows thru & under
pipe; appears to be coming thru penstock pipe initially.
42" Reservoir drain under spillway is plugged w/ concrete

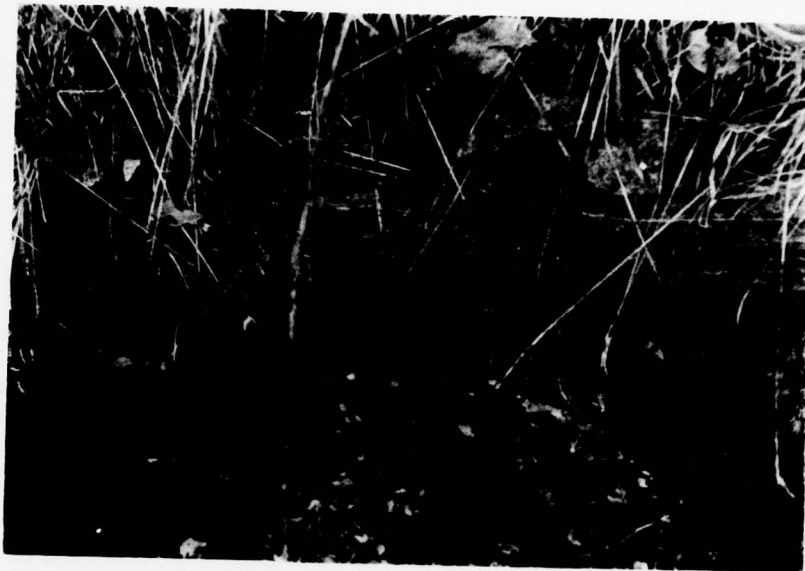
Photo #10

Slight bulging was observed in the stone masonry on either side of the penstock for a total distance of approximately 16 feet. No recent movement was observed in this 2 to 3 inch bulge. This bulge may have been the result of mis-alignment during construction.

PENSTOCK AS VIEWED FROM TOP OF DAM
NOTE: SLIGHT BULGE IN MASONRY

6. At bi-monthly intervals, monitor the bulge on the downstream masonry face in the vicinity of the penstock and the seepage from the penstock and the reservoir drain.

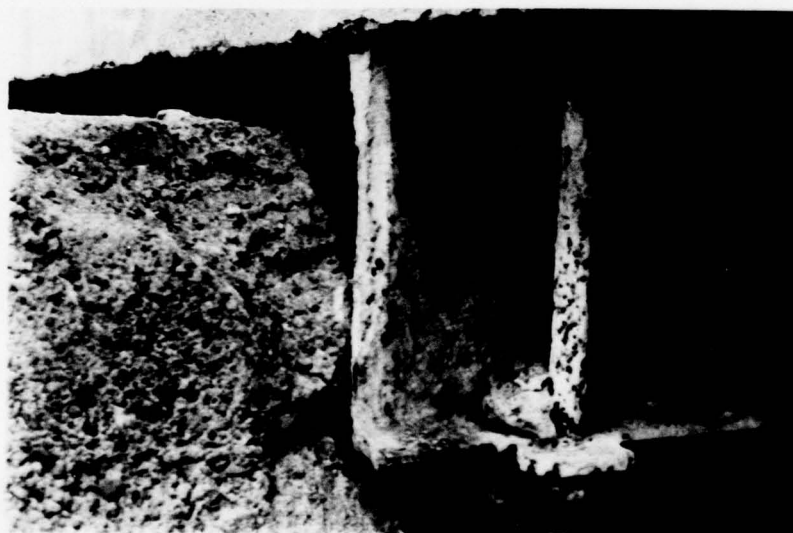
Photo #15

SPILLWAY BRIDGE DECK I - BEAM
NOTE DETERIORATION OF CONCRETE STOPLOG SUPPORT

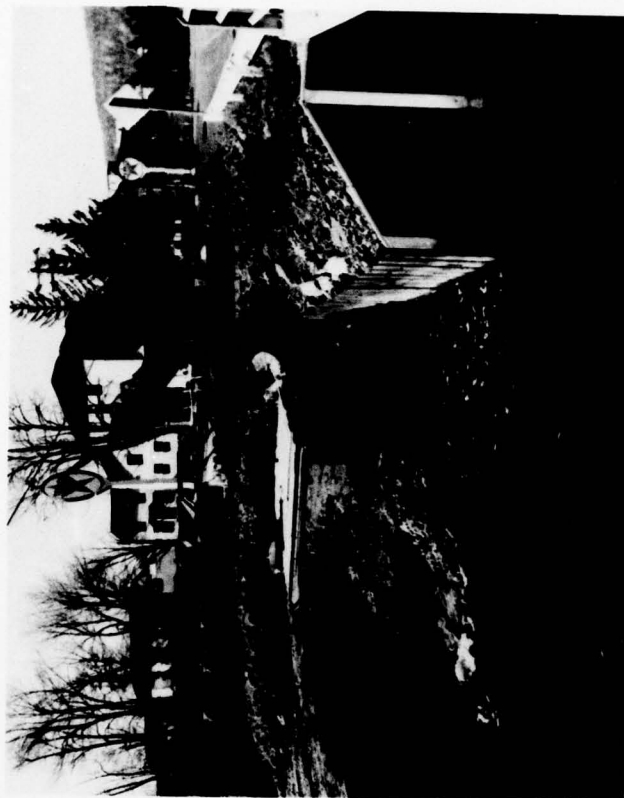
Photo #19

INTAKE AREA FOR PENSTOCK (1962)
NOTE: THIS AREA IS NOW FILLED IN
